Restoring a 20th Century Wooden Boat at Risk: The Case of Lambousa Project

Constantinos Nicolaou*,
Marinos Ioannides, Panayiotis N. Panayiotou, Petros Siegkas, Athos Agapiou, Stelios Fotiou, Giorgos Neofytou, Elena Karittevli, Drew Baker, Nicolas Demetriou**

The Vessel's Biography

The Restoration Project

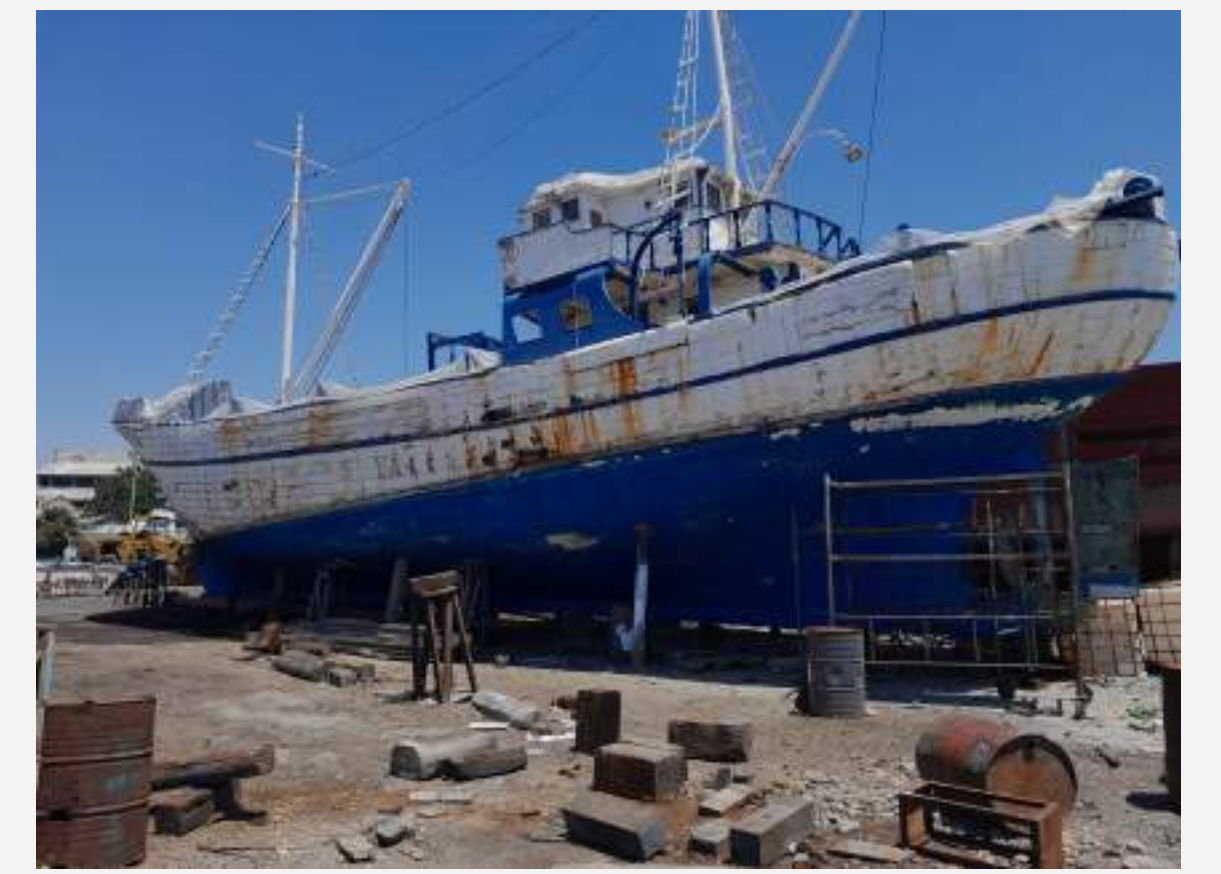
Dry-docked in Limassol shipyard, 2022

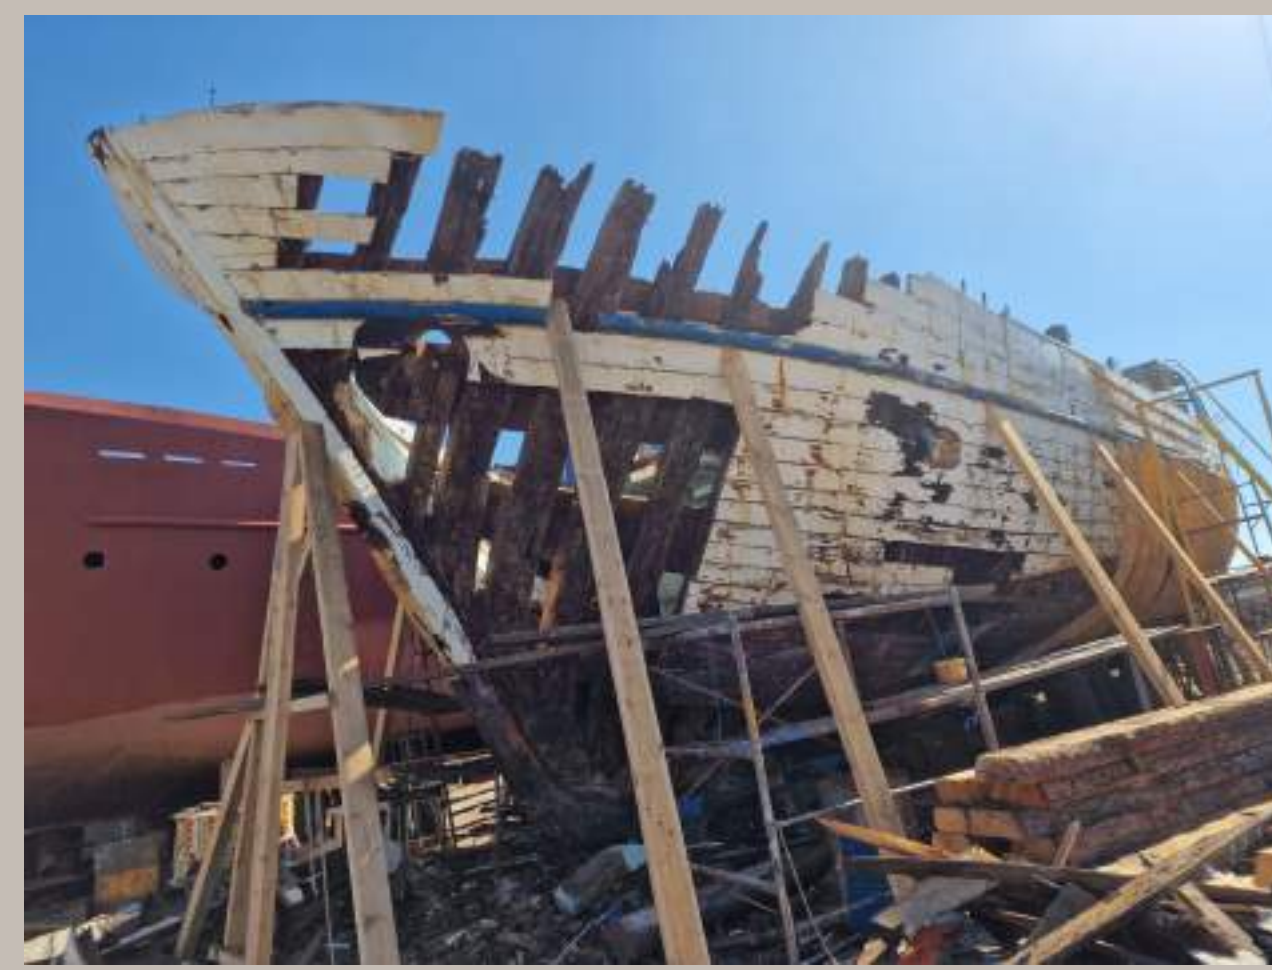
Lambousa during restoration

A combination of simultaneous works, was undertaken by more than 20 craftsmen of different specialties including shipwrights, blacksmiths, mechanics and others, who completed the restoration of the boat in one year! The procedure began with the remove of the superstructures, the mechanical and fishing equipment which were then transferred to a workshop for maintenance simultaneously with the rest of the works. Then the rotten wooden parts of the hull and the deck were gradually replaced from the bow to the stern, in an 'overlapping' process that the construction coherence was not disturbed. The exact shape and the position of the different parts was kept and checked through hundreds of notes and photographs, whereas the shape of the hull (frames and posts) was kept with the use of patterns. After the hull completion, the superstructures, the mechanical and fishing equipment were placed on the boat and the restoration finished with the caulking and painting. During the restoration, more than 50 special parts of the boat's construction that were replaced, saved and will be kept by the Pattichion Historic Archive at Limassol in order to be available for study and for wood species analysis.

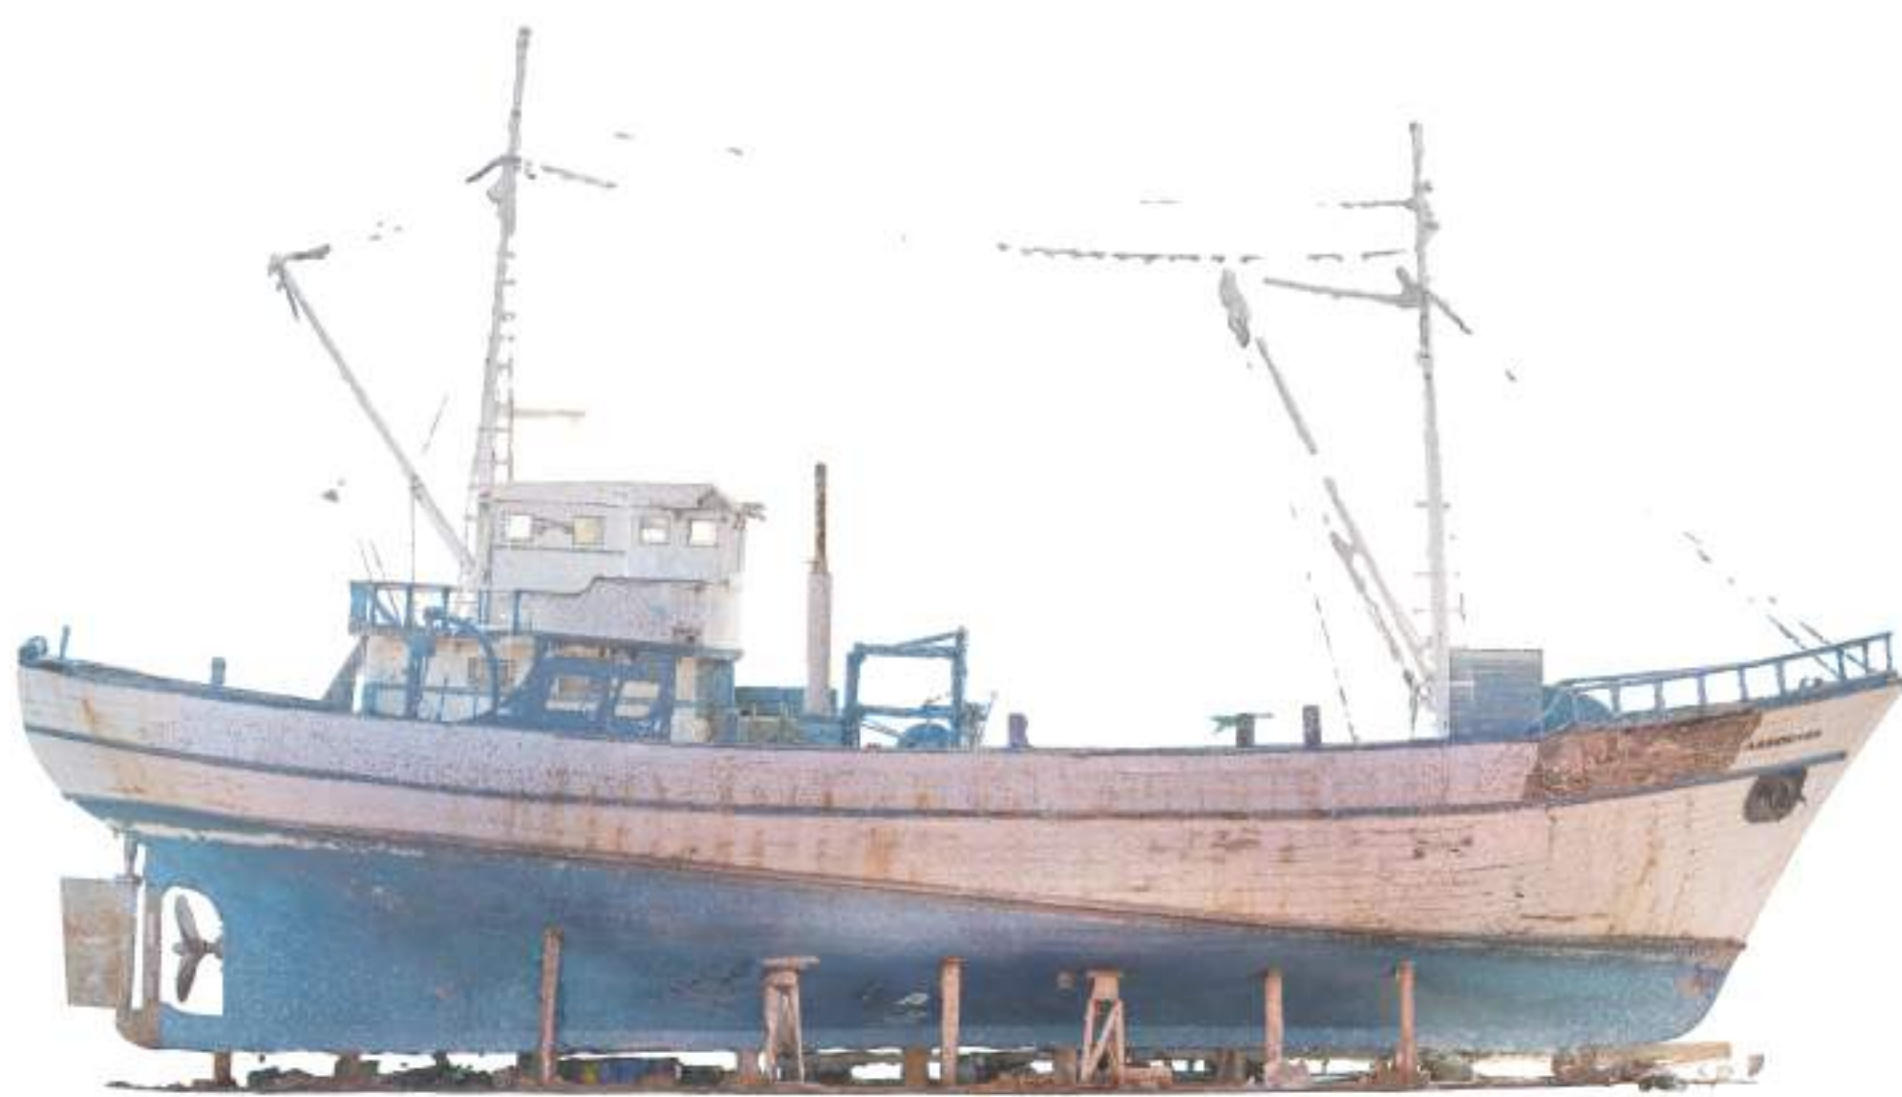
Photogrammetry Point Cloud - Before Restoration

Within the H2020 ERA Chair MNEMOSYNE project, the Lambousa trawler has been fully digitised for its holistic documentation using a newly implemented method. An aerial and terrestrial UAV photogrammetric survey was carried out. The results of this survey include a georeferenced point cloud that is further sampled to 5,000,346 points to allow the data to be further processed. In addition, a survey was conducted in October 2023 through TLS, during the restoration works.

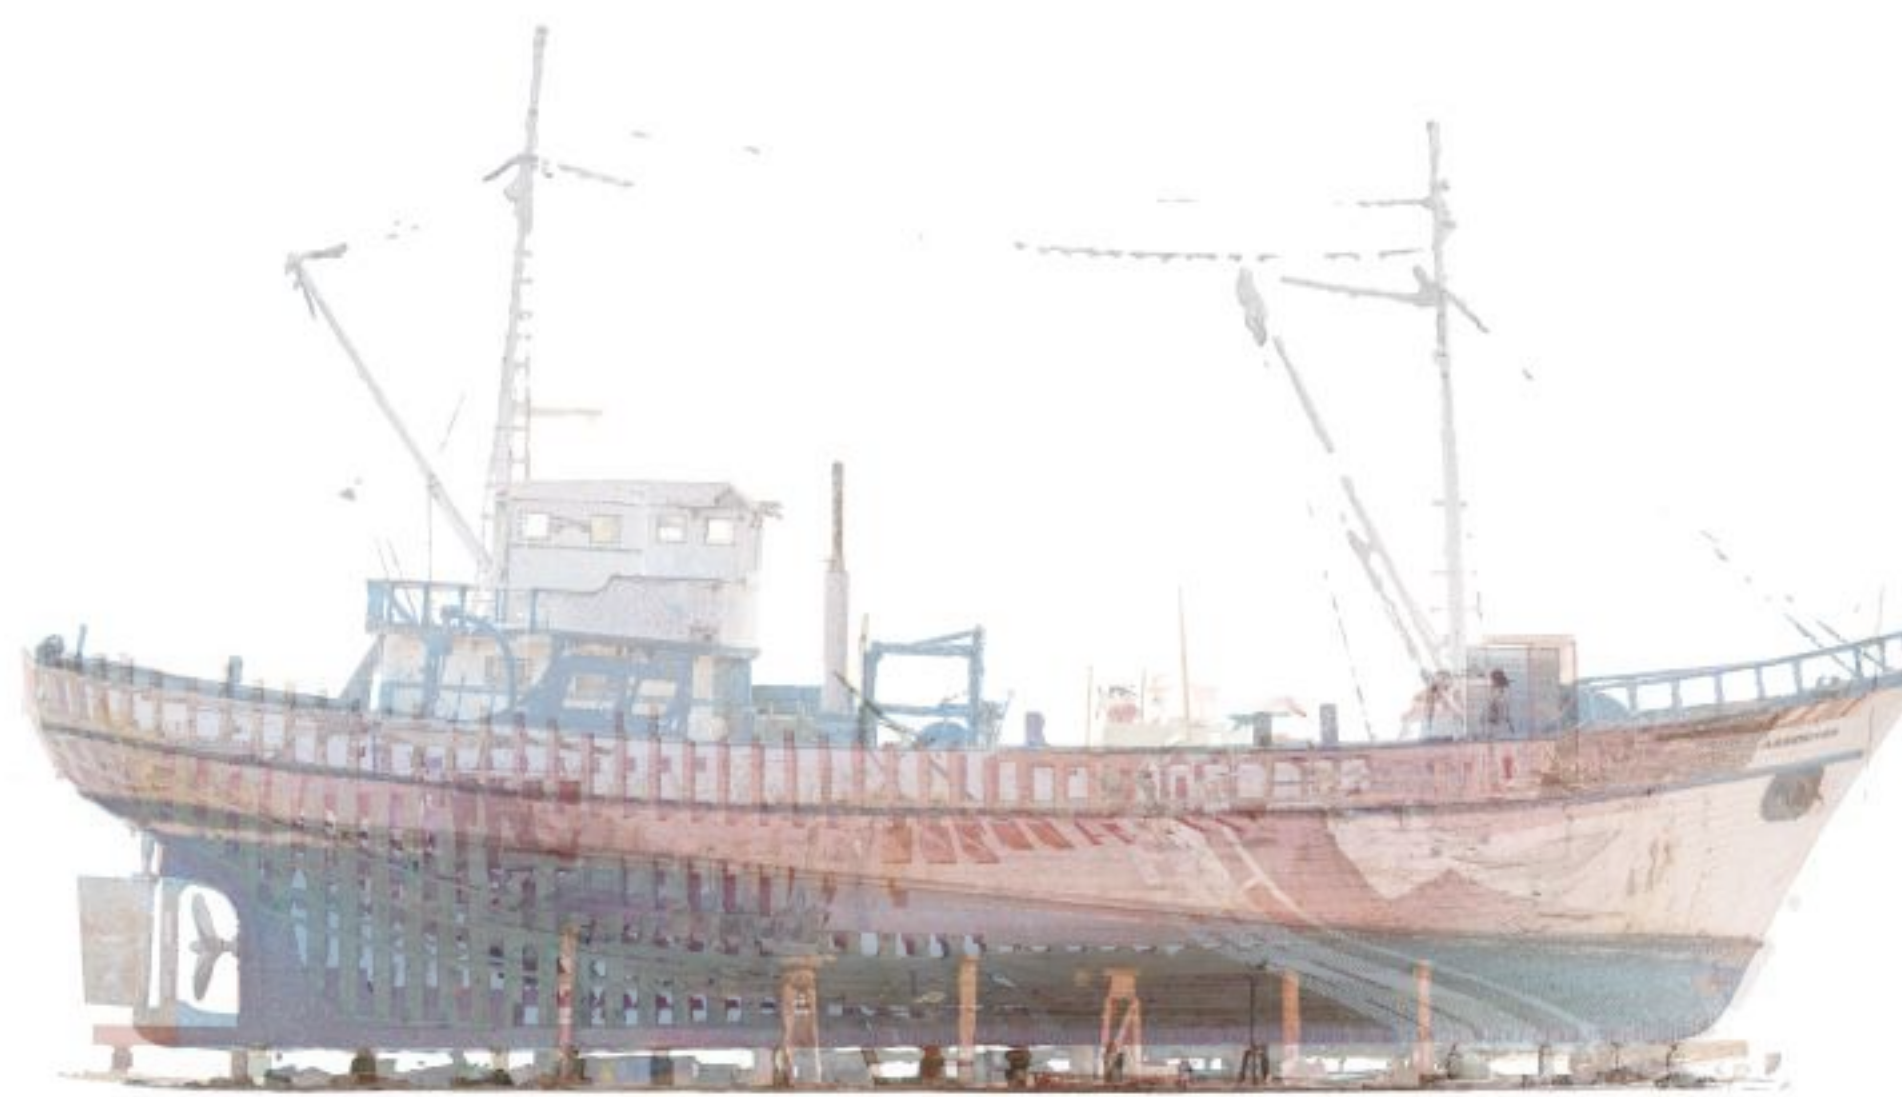
Terrestrial Laser Scanning with Photogrammetry Point Cloud - During Restoration

Within the Digital-Europe EUReka3D project a more detailed digitisation was carried out for the geometrical modelling of the timber frames, the deck beams, the keel, and the stern with a result of 14,164,403 points. In addition, an alignment was made of the TLS with the photogrammetric point cloud, to let the formation of a point cloud for the entire boat. This data is processed in CAD software, to produce closed 3D NURBS geometries of all the components of the vessel. Specifically, the network of curves for the hull is created based on vertical point cloud sections. According to these curves a solid surface of the hull is made which allowed the creation of the deck, the frames, the deck beams, the railcap, the keel, and the stern. Additionally, the rest of the elements such as the fishhold, cabin, and mast are produced by tracing curves across the point cloud. The result is a 3D model of the vessel with 440 components. Furthermore, detailed naval architectural drawings are made based on 3D geometry as well as a deviation analysis to compare the vessel before and after its restoration. An online platform has been developed to aggregate the unique memory of this trawler. This gives the multidisciplinary community an opportunity to have in-depth knowledge and understanding of the vessel's controversial past. The platform can be accessed by activating the QR Code.

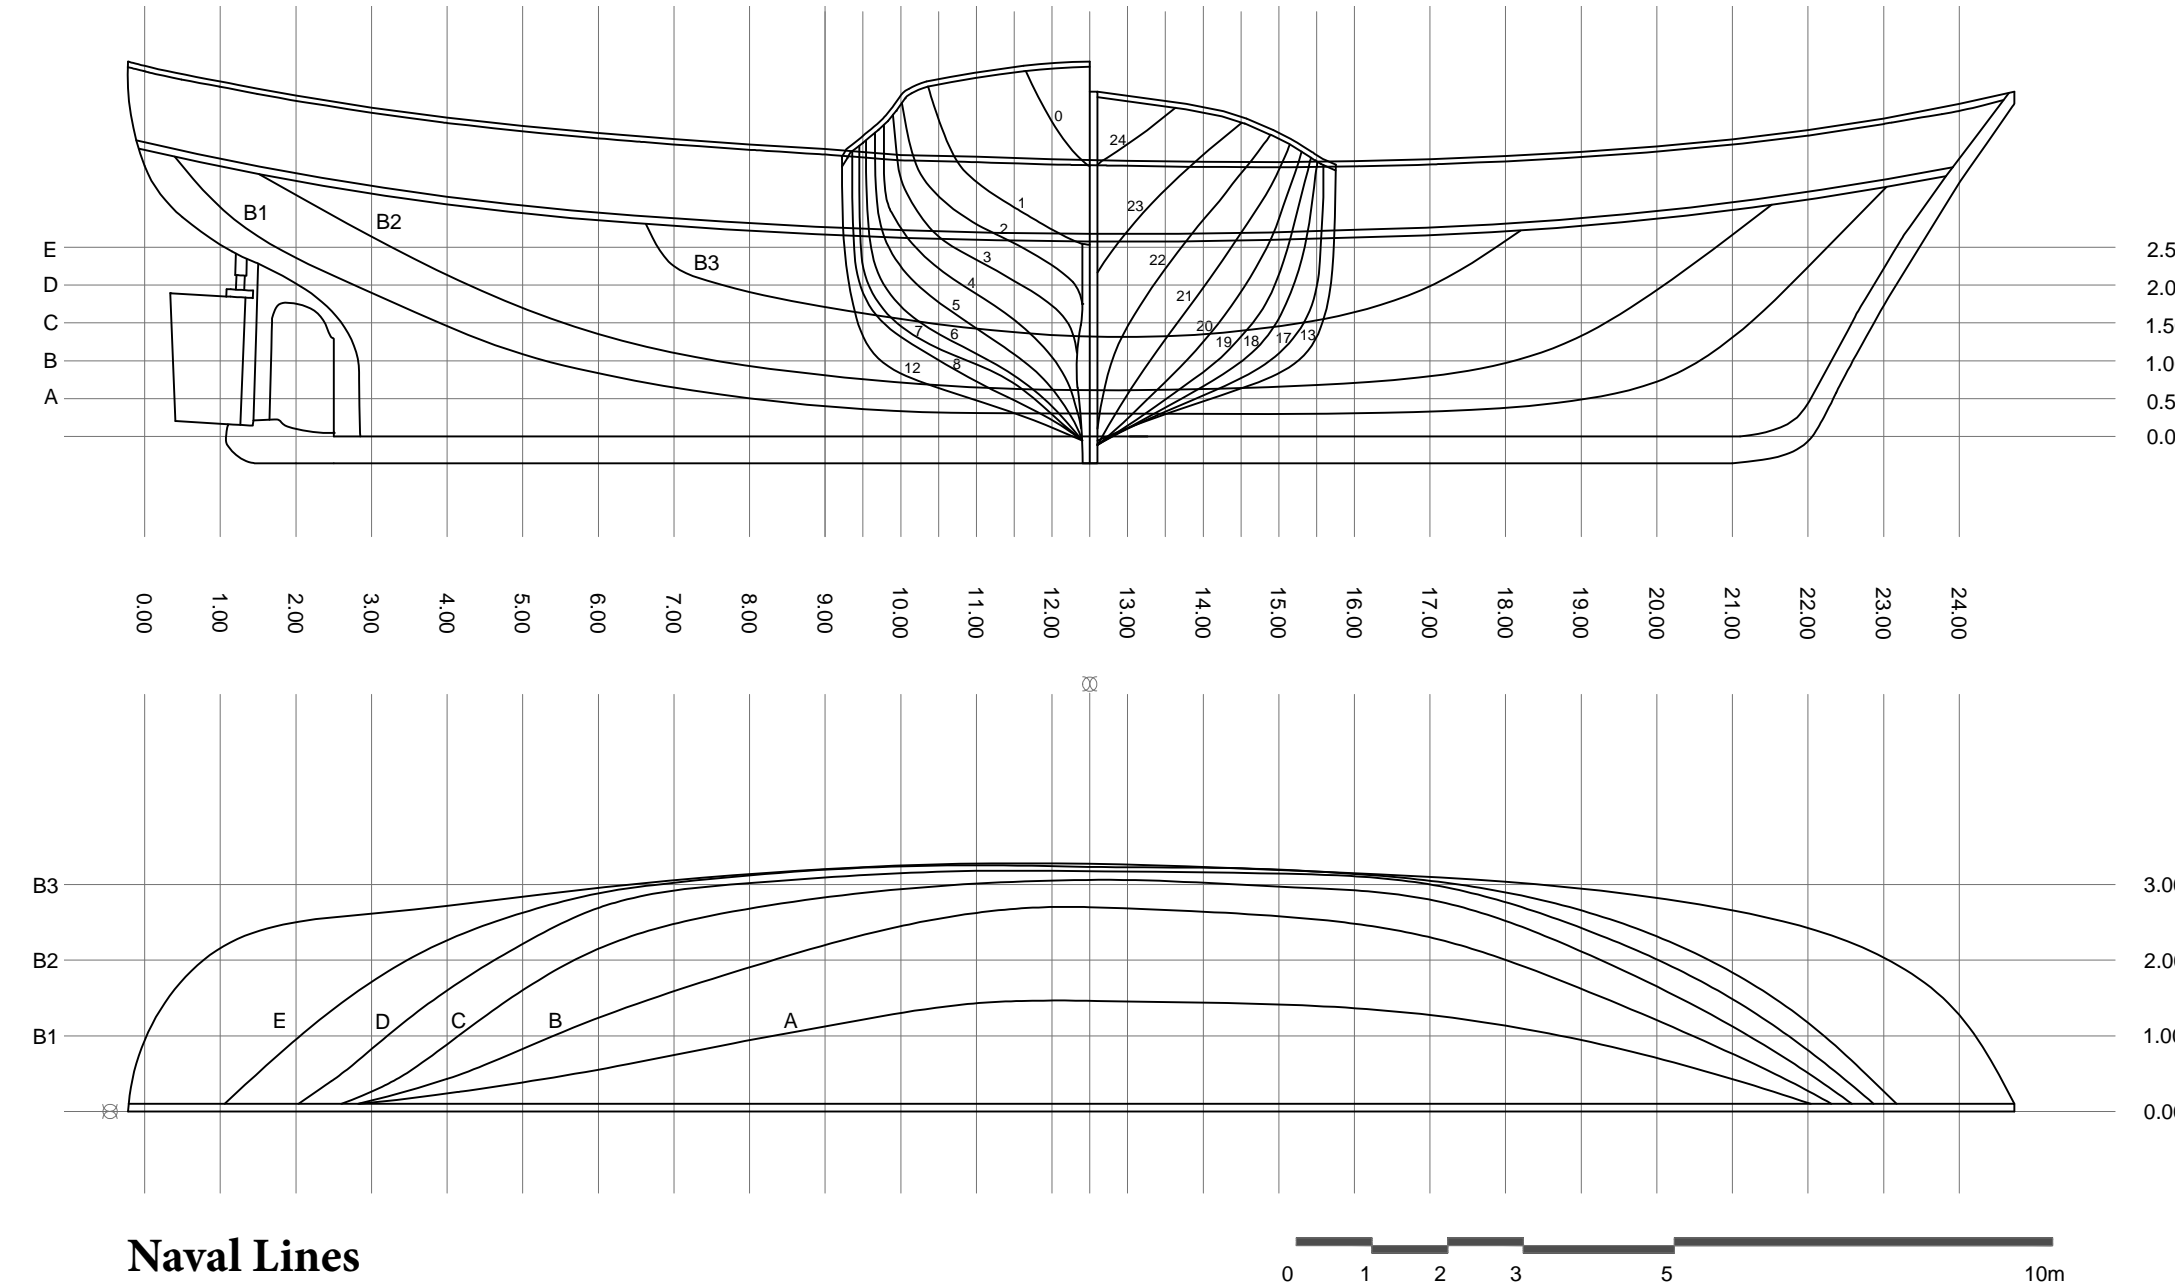
Naval Lines

Basic Dimensions - Construction Deviations		
	Before Restoration	After Restoration
Length Over All (L.O.A)	24,95m	25,55m
Maximum Breadth (M.B.)	6,54m	6,54m
Length of the Keel (L.K.)	19,93m	19,86m
Length of Bow (L.B.)	3,73m	4,15m
Length of Stern (L.S.)	2,72m	2,90m
Depth of Bow (D.B.)	4,91m	4,89m
Depth of Stern (D.S.)	5,31m	5,35m
Height of the Mid-frame (M.D.)	4,02m	4,02m

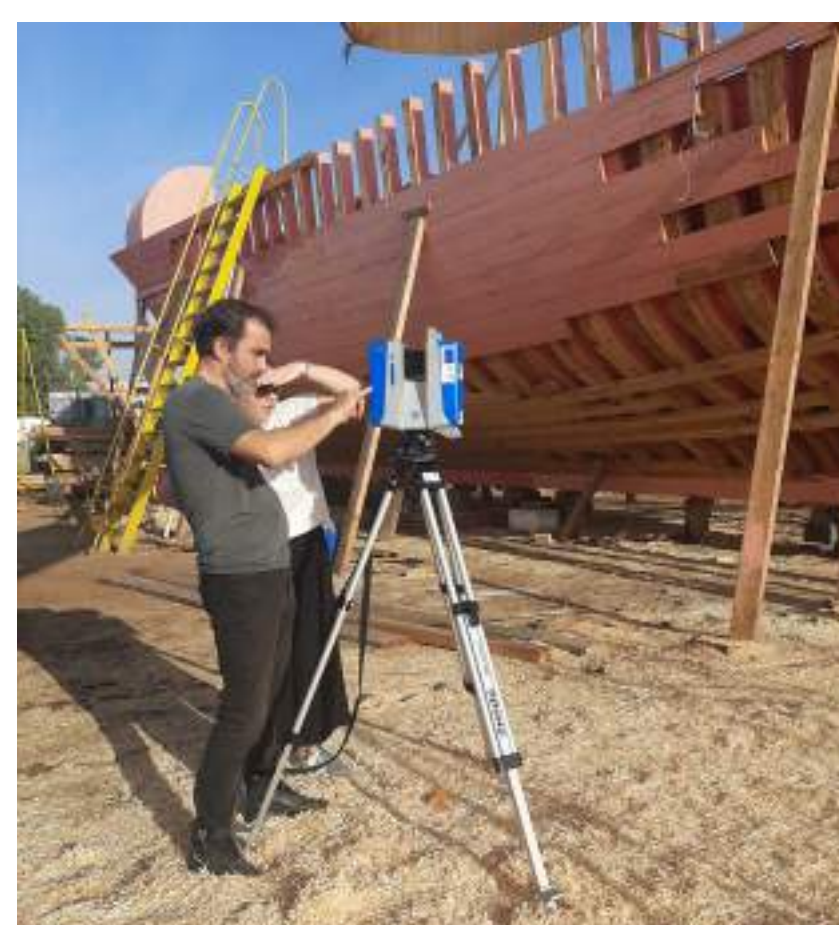
Terrestrial Laser Scanning at the shipyard

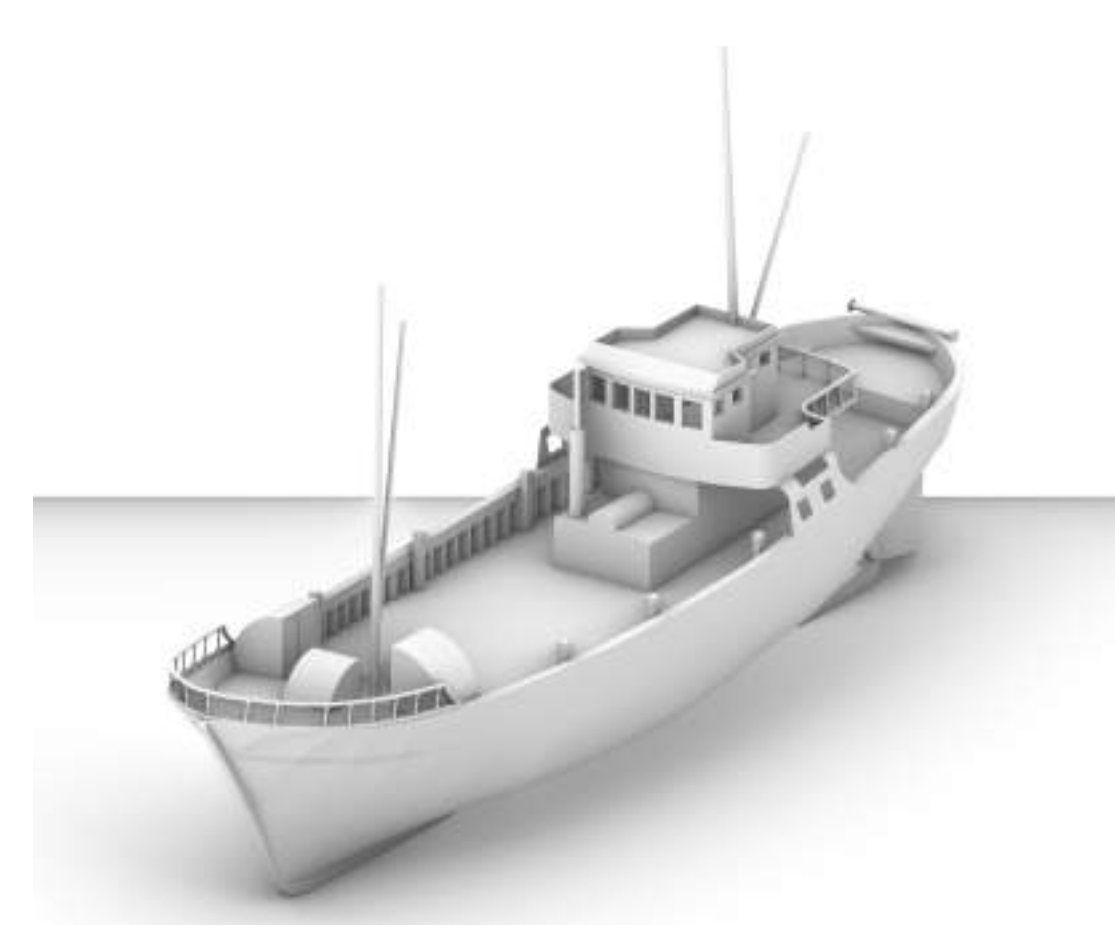
3D CAD Model - Axonometric

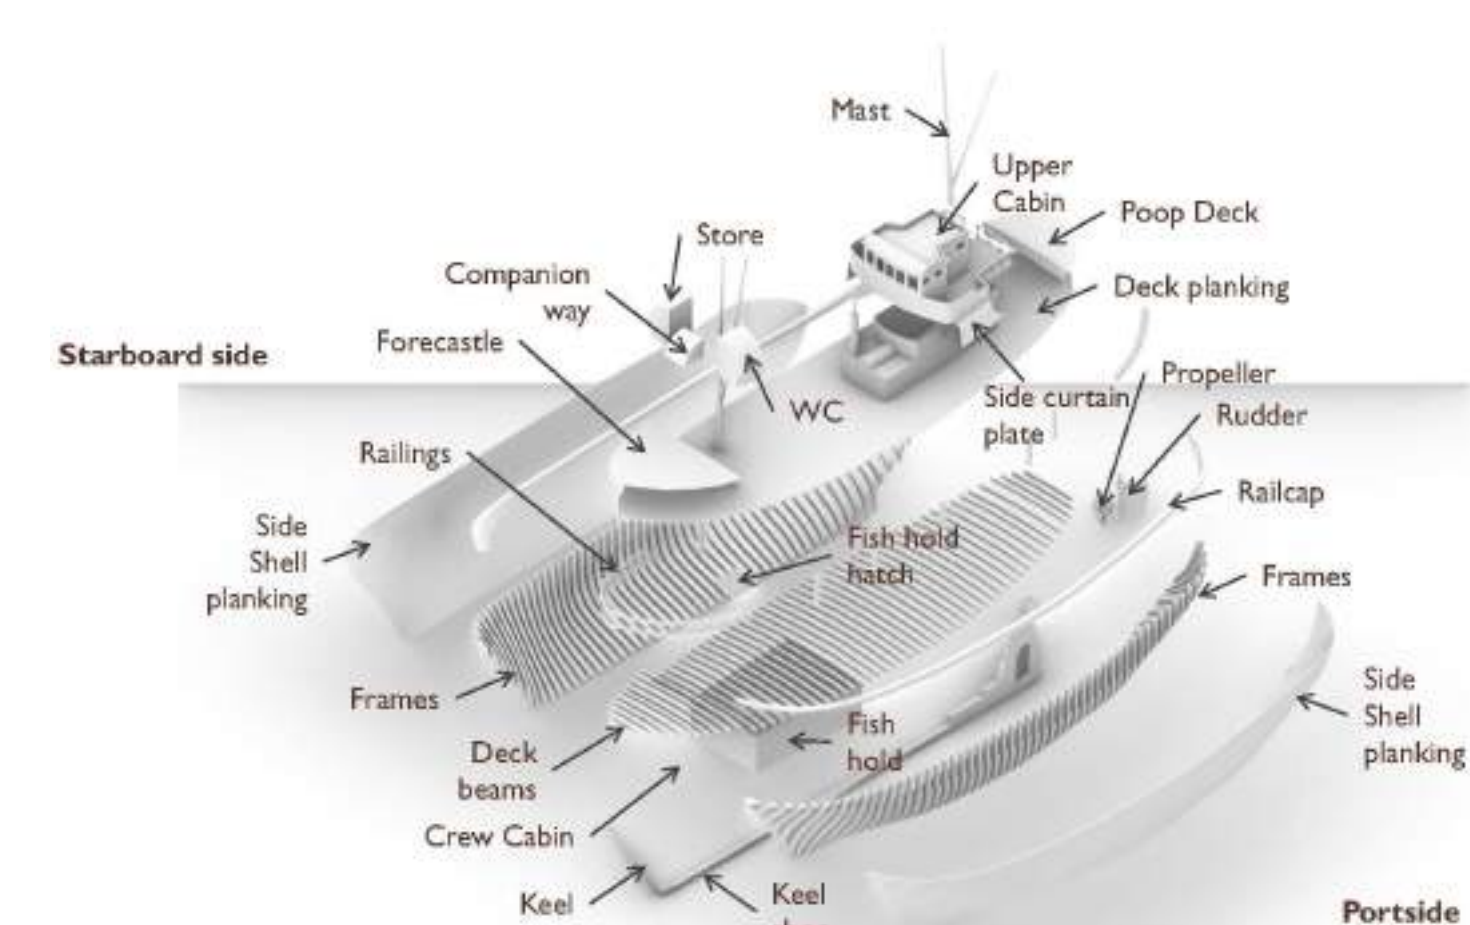
3D CAD Model - Exploded Axonometric
